A Picture Is Worth

STITT®
SPARK PLUG COMPANY

Many times an engine problem can be solved by carefully examining its spark plugs for visual clues to abnormal conditions that may exist in the engine's power cylinders.

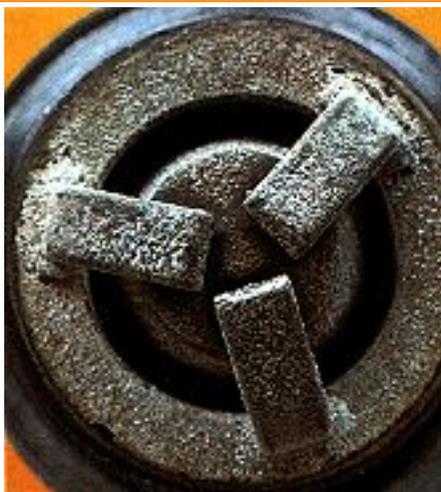
Light casting of whitish ash uniformly deposited on firing-end.

NORMAL FIRING-END.

Normal, light ash deposits are common indicators of healthy spark plugs from a healthy engine.

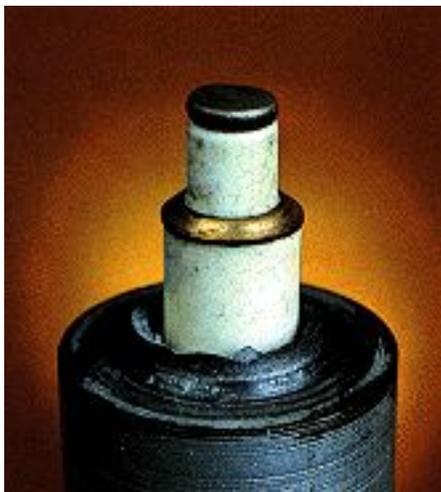
Shear fracture of steel spark plug shell at the thread relief.

OVER-TORQUE. Spark plug steel can only withstand so much torque. Over-torqueing can exceed the strength of the spark plug's thread relief. Federal Spark Plug Standards require that 14mm spark plugs only withstand 45 ft. lbs. without damage; 18mm only 65 ft. lbs.; and 7/8"-18 only 85 ft. lbs. Only by using an indicating torque wrench can this over-torque damage be eliminated.

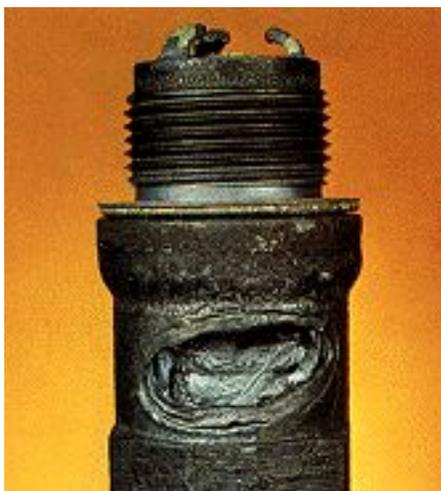
Torched-out hole in spark plug's steel shell. Probably but not always a melted firing-end as well.

TORCH-EFFECT DETONATION. This is an extremely destructive engine event known to blow holes in pistons, cylinder liners, and cylinder heads. Check engine timing, mixture controls, and all engine functions.

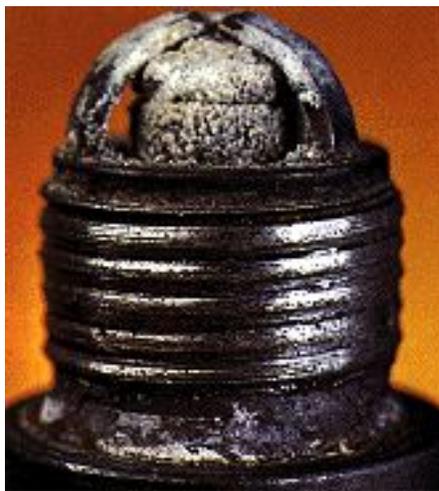
Spark plug's threads flattened, torn or missing.

CROSS-THREADING. Threads that have lost their sharpness usually indicate that the spark plug has been cross-threaded or installed in a port which has been tapped undersize. Crossthreading can occur when the plug installation is not started by hand. A good solution is to install all plugs hand tight before final mechanical torque is applied.

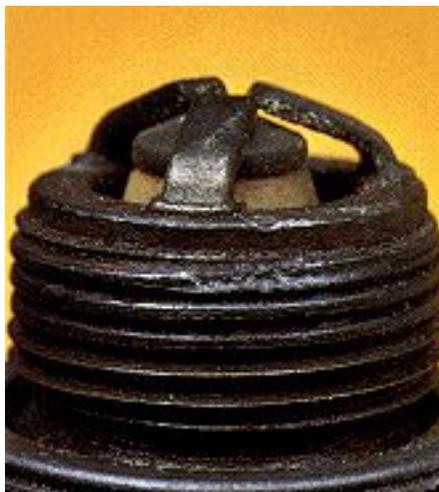
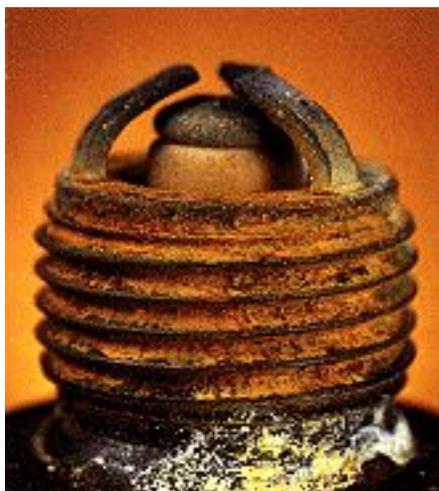
Orange-colored residue on threads or spark plug firing-end .

COOLANT-ADDITIVE RESIDUE. This orange colored material is the residue from an engine coolant-additive. When found on the spark plug threads, it indicates that cylinder head is probably cracked in the area of the spark plug port threads.

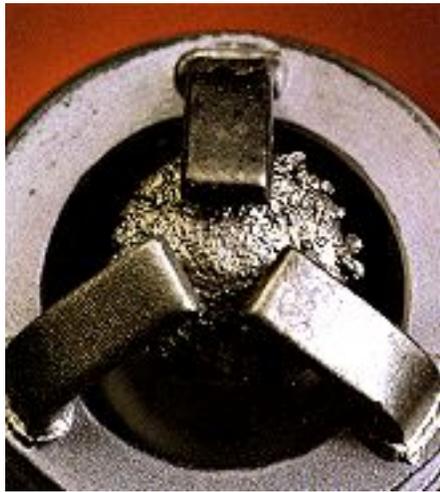
Molten center electrode or melted ground electrodes and center electrode. Possibly fractured and melted ceramic. Occasionally, melted steel shell.

PRE-IGNITION/DETONATION.

A melted nickel center electrode and/or melted ground electrodes always indicate that the spark plug has encountered higher than normal operating temperatures. Since the melting temperature of nickel is 2600°F, melting nickel indicates that the spark plug has probably been a victim of sustained pre-ignition or detonation. Check engine timing, mixture controls, and all engine functions.

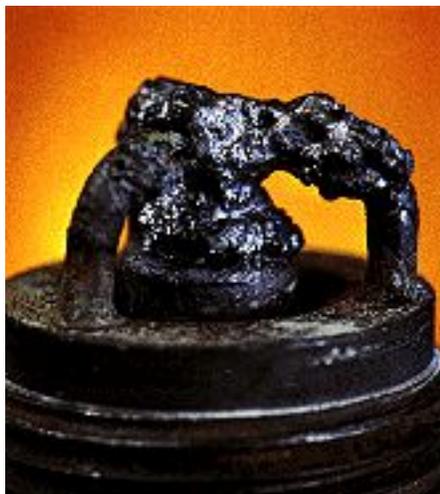
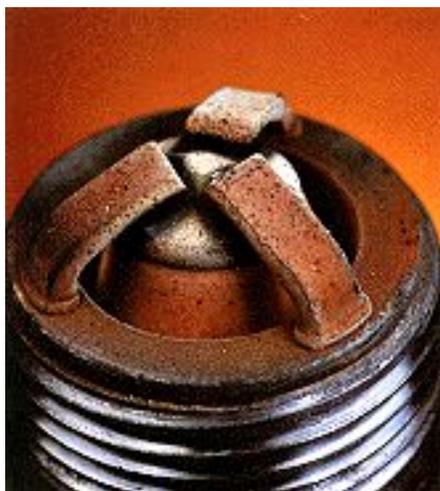
Red, grainy deposits on insulator nose and firing-end.

IRON OXIDE DEPOSITS.

Firing-end deposits of iron-oxide may prevent the discharge of energy across the spark gap. These iron oxide deposits usually indicate that there may be corrosion in the fuel gas line or the main transmission pipeline. If the engine has cylinder injection air starters, corrosion may also be found there. Lastly, iron oxide deposits may indicate a cracked cylinder head.

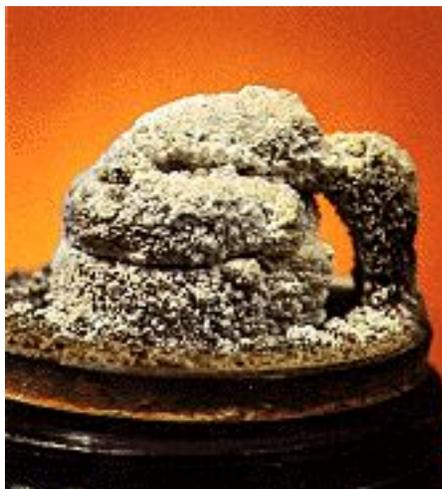
Crusty, white deposits accumulating on firing-end.

BARIUM/CALCIUM FOULING.

The use of high-ash lubricating oils affect the performance of an engine's spark plugs. If you suspect this operating problem, check the engine manufacturer's lube oil specifications. If ash content of lube oil used does not conform to manufacturer's specifications, change to a recommended lube oil. If engine provides power cylinder lubrication, check power cylinder lubrication rate to assure that lubrication rate is within specifications. If the lube oil is one recommended by engine manufacturer's specifications, check that cylinder liners are not scuffed or scored. Next, check engine lube oil consumption history and then check the piston rings. If lube oil ash deposits indicate an excessive accumulation in one quadrant of firing end, lube oil leakage down intake valve guides may be indicated.

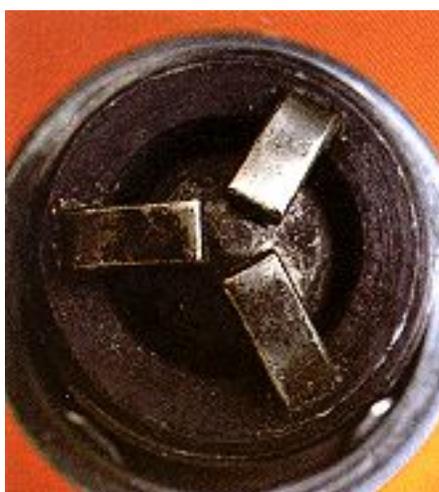
Black, fluffy deposits on firing-end.

CARBON DEPOSITS. Fluffy black carbon deposits usually indicate too rich a fuel/oxygen mixture. If a change in the mixture to a leaner setting fails to remedy this carbon fouling, try using Stitt's next hotter heat range spark plug.

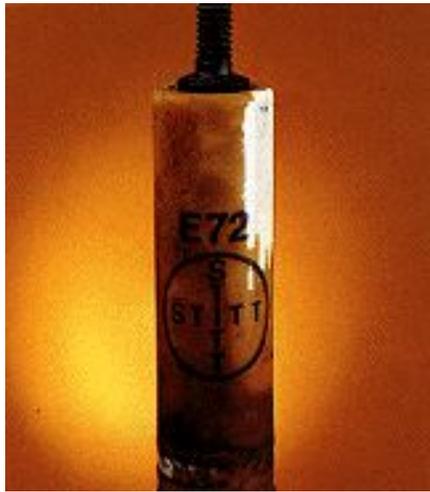
Coked lubricating oil on spark plug insulator. Could also be paint or other conductive material.

CONDUCTIVE CONTAMINANTS ON FLASHOVER PORTION OF INSULATOR.

Paint, coked lube oil, grease and other conductive materials can cause misfiring by promoting flashover. Make every effort to keep the flashover portion of the spark plug insulator clean and free of conductive contaminants.

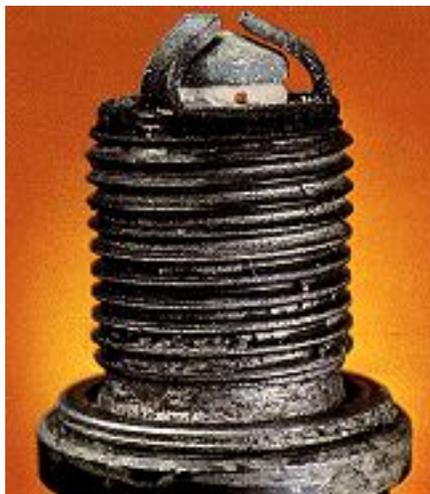
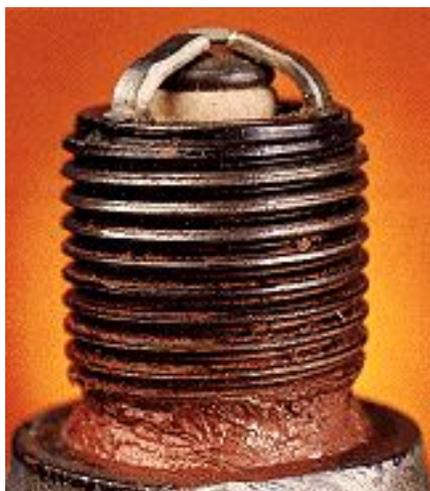
Heavy residue of gray-colored or copper-colored compound in threads.

EXCESSIVE APPLICATION THREAD LUBRICANT.

Too much thread lubricant can eventually cause problems. Though thread lubricants can have antigalling properties if used sparingly, too much can allow an excessive increase in the clamping force and this can make the spark plug impossible to remove. If heavy quantities of thread lubricant have been the practice of spark plug installation, we recommend that the carbonized residue be removed from the cylinder head's spark plug ports at each plug change by using a thread chaser/seat cleaning tool or a full bottom tap. If solid-state ignition systems are being operated, special care should be taken to remove carbonized thread lubricant in the port threads. This material can add resistance to the ground return circuit of the ignition system and can affect ignition performance.

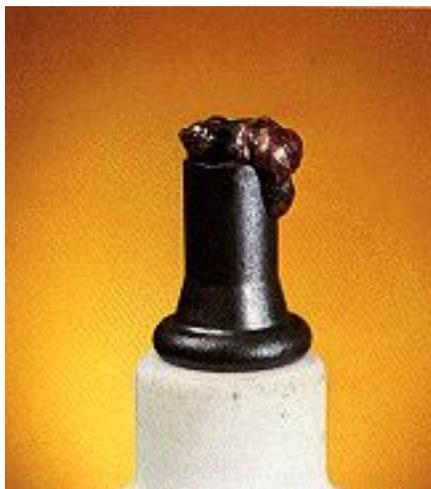
Copper deposits on center electrode, possibly bridging spark gap to ground electrode(s).

COPPER RUN-OUT. If spark plugs with copper in the center electrode operate at excessively high temperatures, copper run-out generally occurs when the center electrode temperature has exceeded 1900°F, a temperature much higher than the design-intended operating temperature of the electrode. This run-out of copper almost always shorts out the spark plug by bridging the spark gap. Check all engine functions that can prevent spark plugs from operating within their design-intended temperature range. Check to determine if too hot a heat range spark plug has been used in a high output engine. Or perhaps too much or too little installation torque has caused this problem. If so, make sure that spark plugs are being installed with an indicating torque wrench to the spark plug manufacturer's recommendations. Pre-ignition may also be indicated when copper runout is observed with ignition too far advanced or mixture too lean. To extend the spark plug's temperature range, consider the substitution of spark plugs with electrodes of solid nickel, which will extend temperature limit of center electrode to 2800°F before melting occurs.
